Collapse of Braced Excavation in Singapore

Ishihara, Kenji

ABSTRACT: After the collapse of the subway excavation in the Nicoll Highway, extensive in-situ investigations were carried out to identify causes of the accident. The results of detailed studies disclosed that lack of toe-in depth of the diaphragm wall into the stiff competent strata could be one of the causes of the incident. This aspect of the studies is highlighted in this paper.

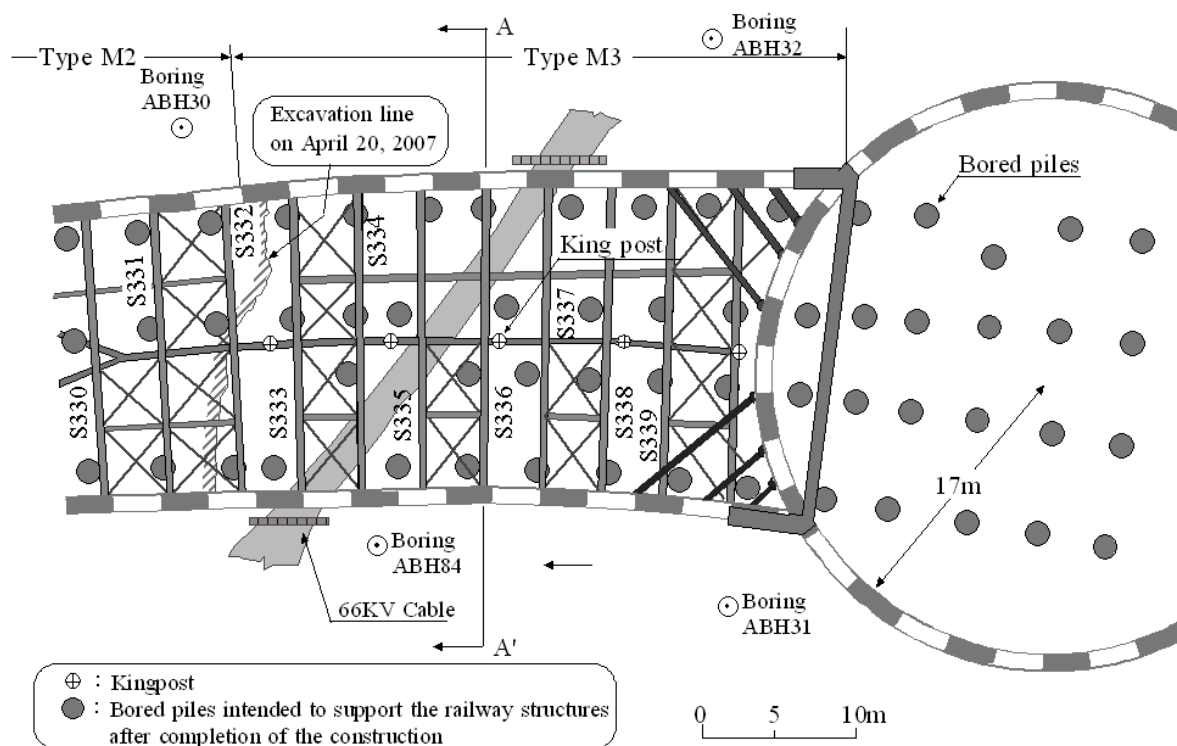
Fig. 5 Plan view of the Type M3 section due west of the access shaft.

forcement cages, concrete was poured in by Tremie pipes. Joints of neighboring elements of the wall was sealed against water penetration, but not rigidly connected as structures. The diaphragm walls, over the section Type M3, were for the curved stretch closest to the access shaft and constructed in May 2003. The walls were designed to be extended 3m into the stiff base layer called Old Alluvium (OA-layer). A detailed plan view of the M3 section is shown in Fig. 5 and a typical side views of the strutting system for the cross section A-A' is displayed in Fig. 6.

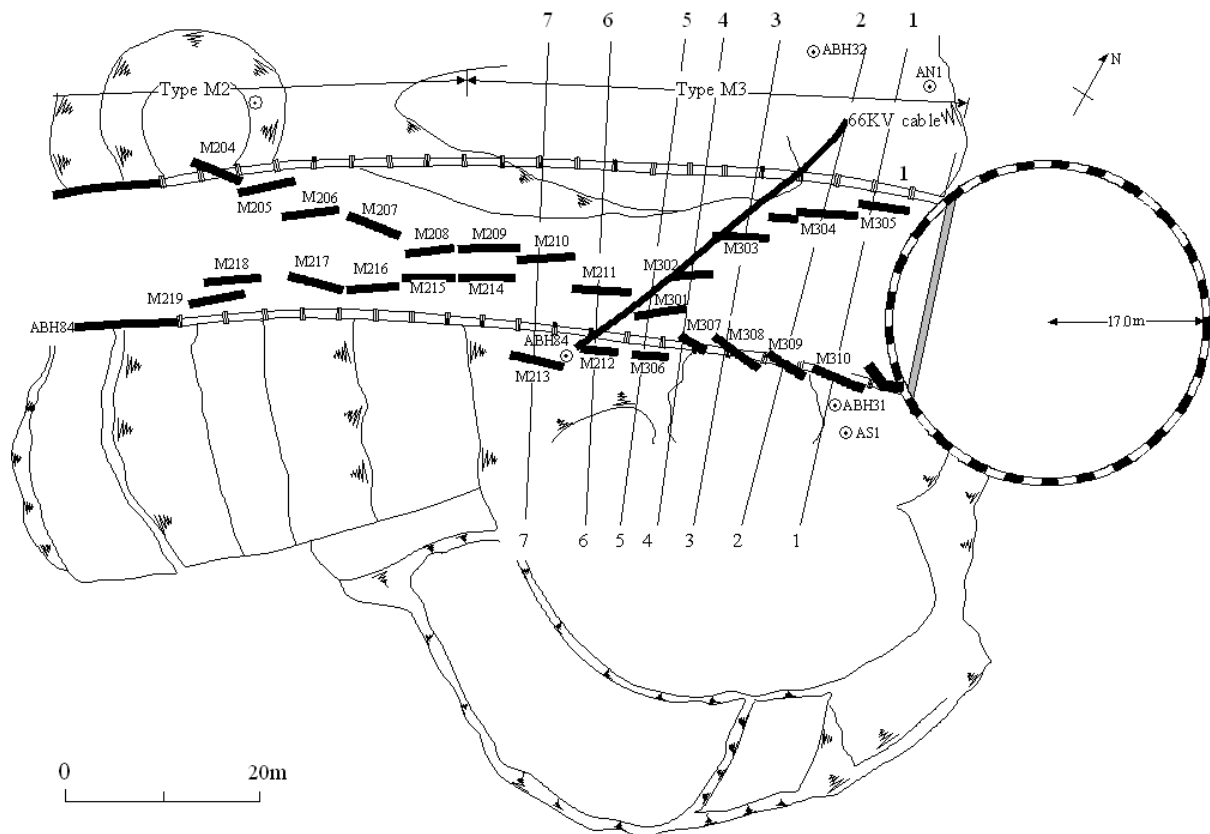
Fig.14 Cross sections for which the damage features were depicted.

As a result of the post-incident in-situ investigations as above, it became possible to figure out approximately the states of collapse for each of the cross sections indicated in Fig. 14. Shown in Fig. 15 are probable features of the collapsed water-strut system buried within the ground which were speculated for the cross section 1, 5 and 7. It is to be noticed that in the cross section 1 and 5, the intermediate layer F_2 is inclined towards the excavation as verified by the boring data at ABH31 and 32 and also at AS1 and AN1 conducted after the failure. This is indicative of the settlement of the even deep-seated soil layer involved in the slide.

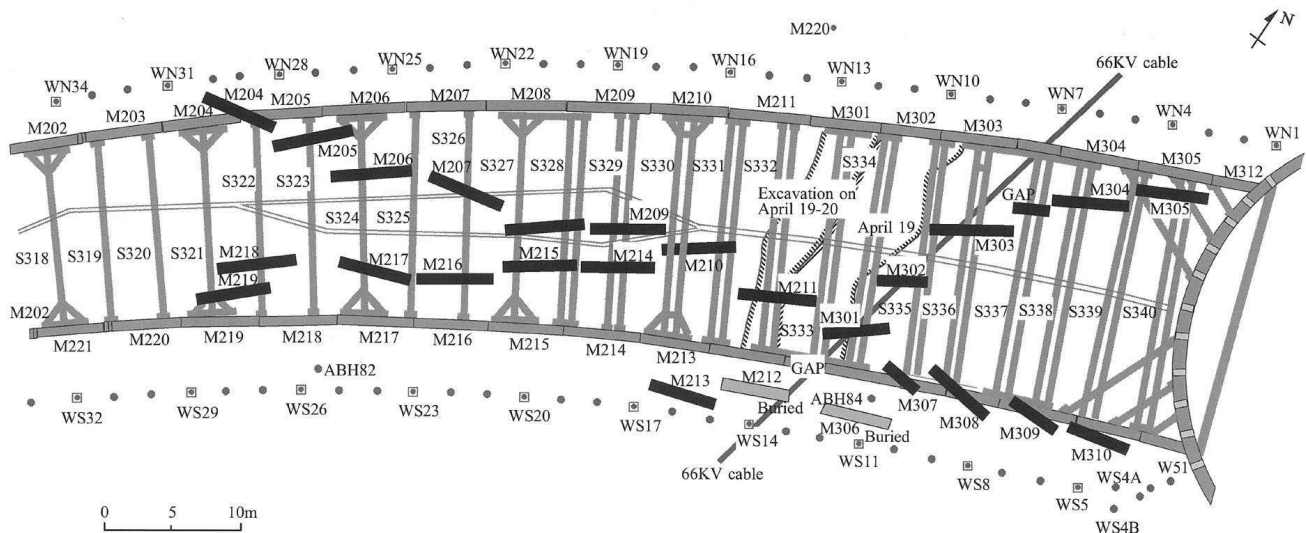
Fig. 18 Detailed arrangements of the struts, diaphragm wall panels and locations of the magnetic logging.

In the area which failed there were inclinometers at or just behind the wall at the north and south sides of the excavation. Shown in Fig. 19 is the time change of depthwise distributions of the wall deflection estimated from the inclinometer, I-104, which had been installed in the soils 1.0m apart from the south wall near M212 (Fig. 18).
